Water Leaks: 01 Kohler Bathroom Faucets

It's a Kohler K-14616 single-handle faucet. It has been discontinued by Kohler. It uses a #1017426 internal valve.

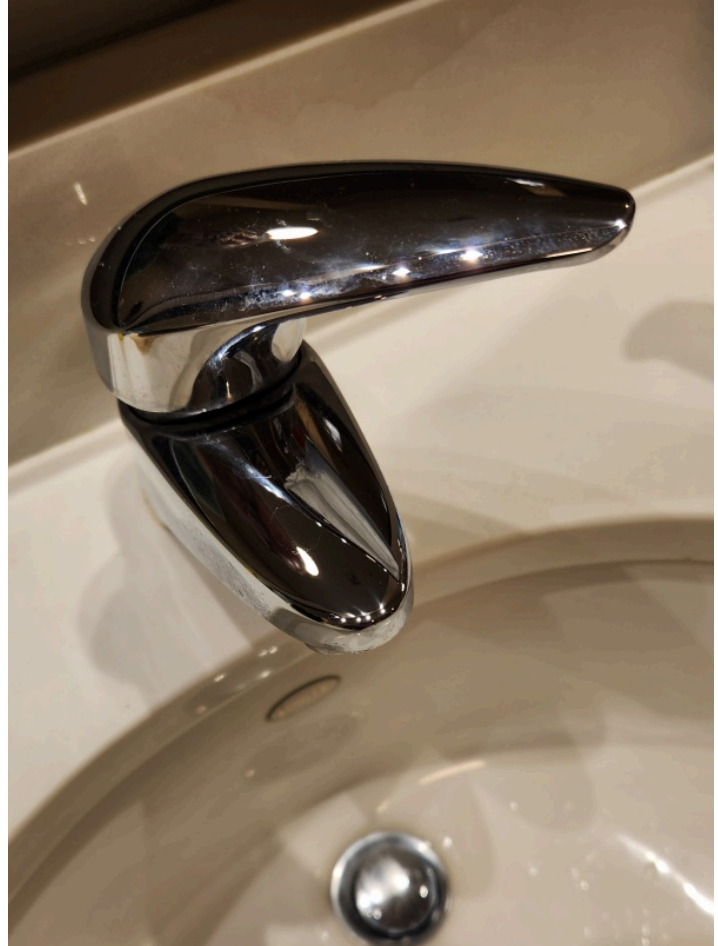
Does your bathroom faucet look like this? This faucet is original equipment at The Vaux.

Investigating further, we saw a narrow stream of water flowing down the back of the faucet and onto the counter.

Turn off water supply: After identifying the source, we got under the sink (removing the treasures stored there) and turned off both the hot and cold water valves. That stopped the stream of water. Because once disturbed these water valves might leak, we put a dry paper towel on the cabinet bottom to show us any drips.

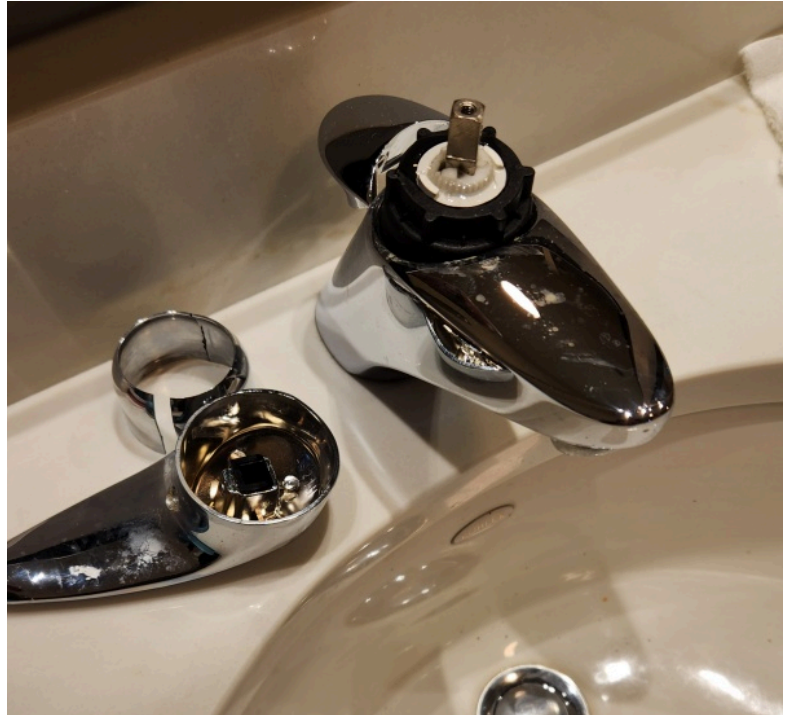
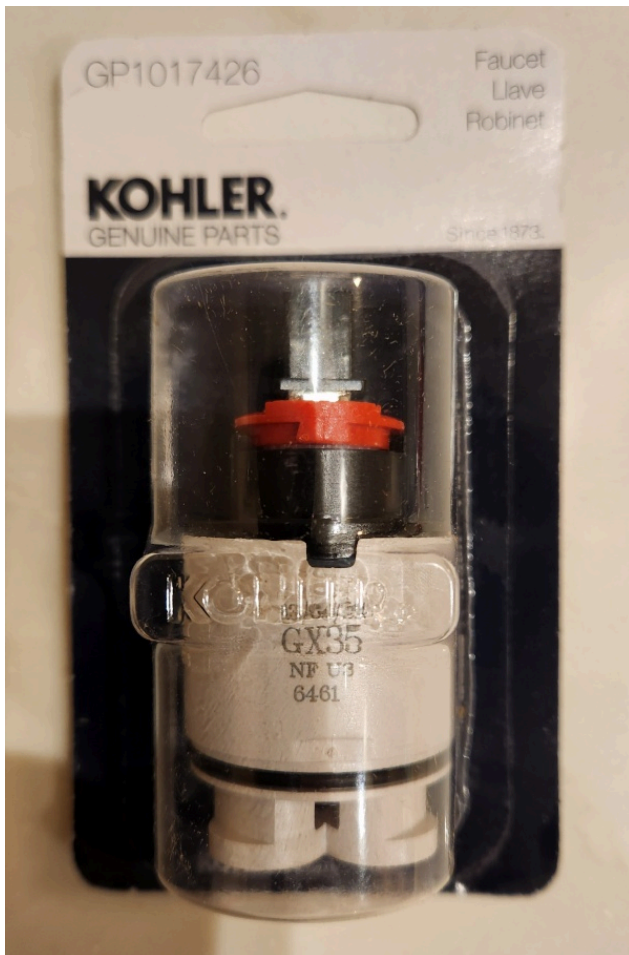
We investigated further (the owner's manual that came with our unit actually showed a photo and the model number of the faucet and valve).

We went online and saw that leaks like this were not unusual for faucets like this. The problem is usually the deterioration of the internal valve.

We shopped online and found the proper replacement valve at Home Depot. Kohler #1017426. Got it delivered the next day, total cost \$16.95.

The replacement valve arrived and we went to work. Removed the faucet handle (there's a little button covering the internal screw that holds the hand

in place), then removed the valve lock (looks like a big plastic nut) with a large pliers, removed the old valve, cleaned out the inside of the faucet, installed the replacement valve, reinstalled the valve lock, turned on one water line and tested. All good. Turned on the other water line and tested again. All good. Cleaned up and closed up. Left dry paper towel on the countertop near the faucet and under the water line valves overnight to detect any drips. No drips. Success!
